LPC 0298050006-Coles
Western Lion Landfill
SF/Tech
ILSFN0507808
9-15-99

CERCLA Integrated Site Assessment

Western Lion Landfill

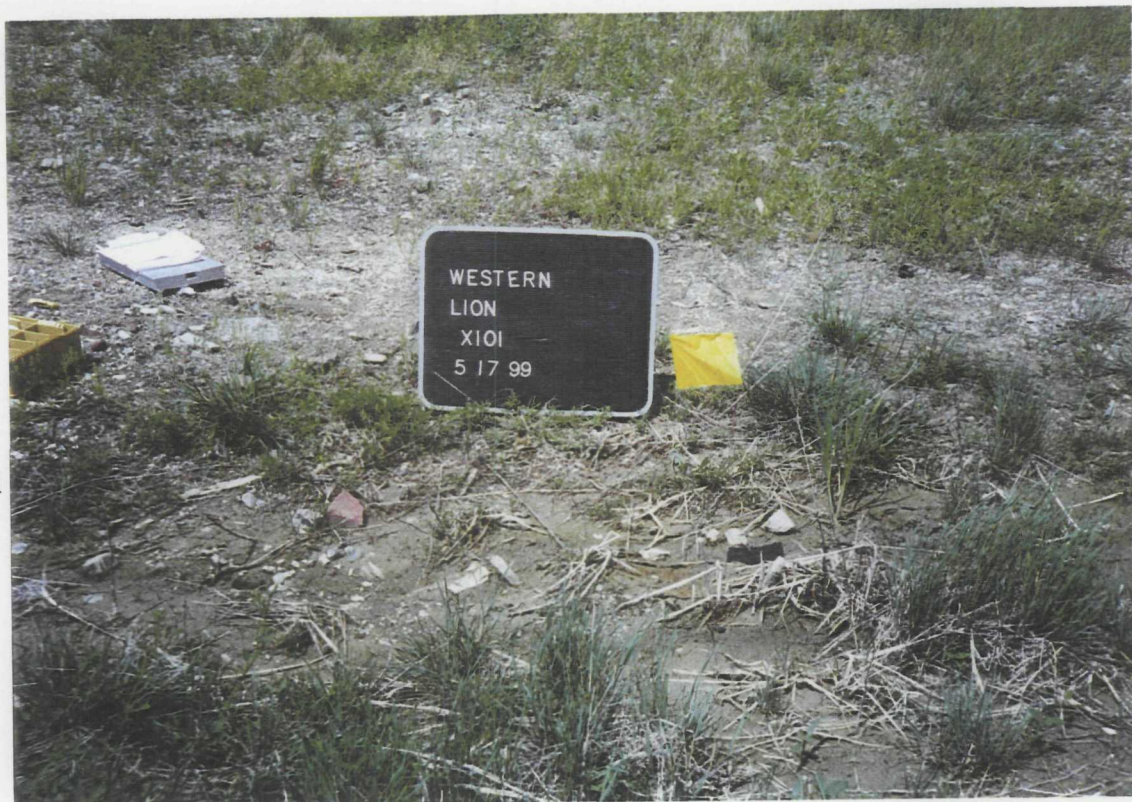
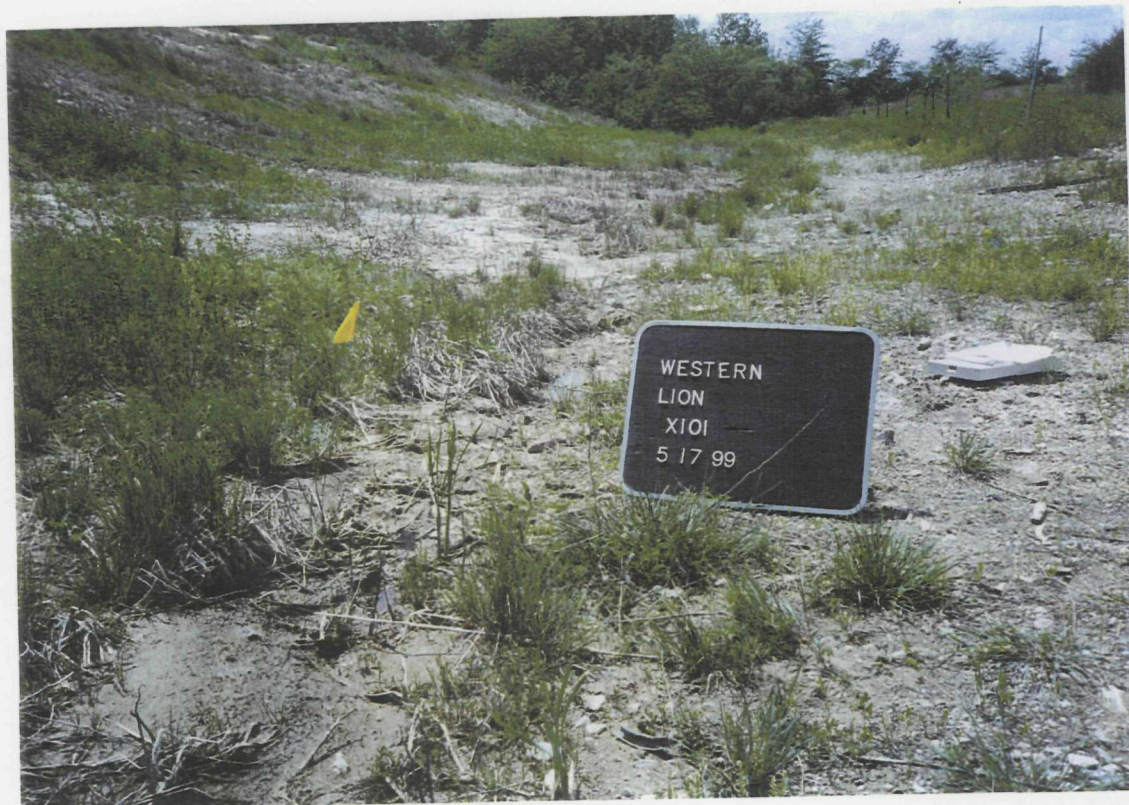
Sample Location: X101

Sample	Depth	Appearance	Location
X101	0 - 2"	Brown silt.	Erosion ditch where overflow from the open pit flows.
X102	0 - 2"	Brown silt.	Erosion ditch where leachate seeps on the north side of the landfill collect.
X103	0 - 2"	Brown silt.	Erosion ditch where leachate seeps on the north and west sides of the landfill collect.
X104	0 - 2"	Brown silt with red staining.	Erosion ditch where leachate seeps on the west side of the landfill collects.
X105	0 - 2"	Brown silt.	Erosion ravine on the west side of the landfill where a major leachate seep flows.
X106	0 - 2"	Brown silt with red and green staining.	Low area that collects leachate from the southwest, south and east sides of the landfill.
X107	0 - 2"	Brown silt.	Low area that collects leachate from the south and east sides of the landfill.
X108	0 - 2"	Brown silt.	Low area that collects leachate from the east side of the landfill.
X109	0 - 2"	Brown silt.	Low area that collects leachate from the east side of the landfill.

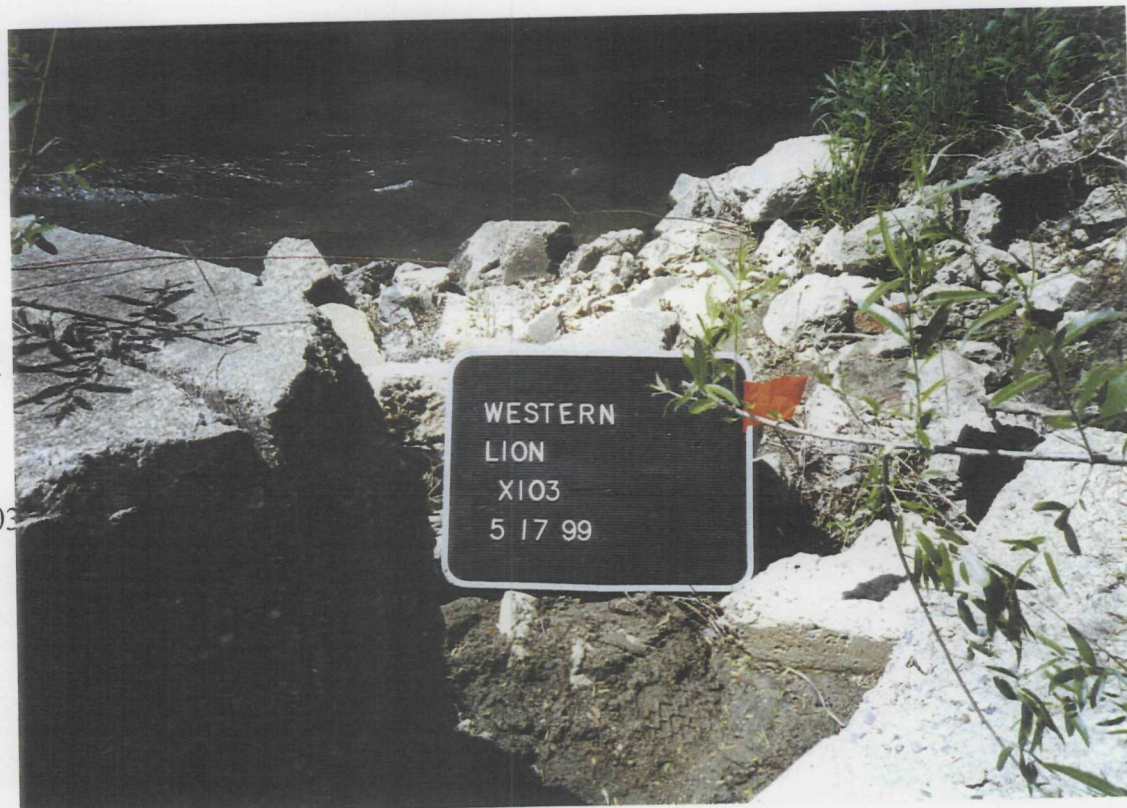
Sample Location: X103

Only one of the nine soil samples exceeded remediation objectives for a contaminant other than arsenic. Soil sample X103 was found to exceed the remediation objectives for benzene, which is a constituent of gasoline. This sample was collected from a point where many of the leachate seeps from the landfill collect prior to entering Riley Creek and is an indication that leachate containing gasoline products has left the landfill and entered the creek.

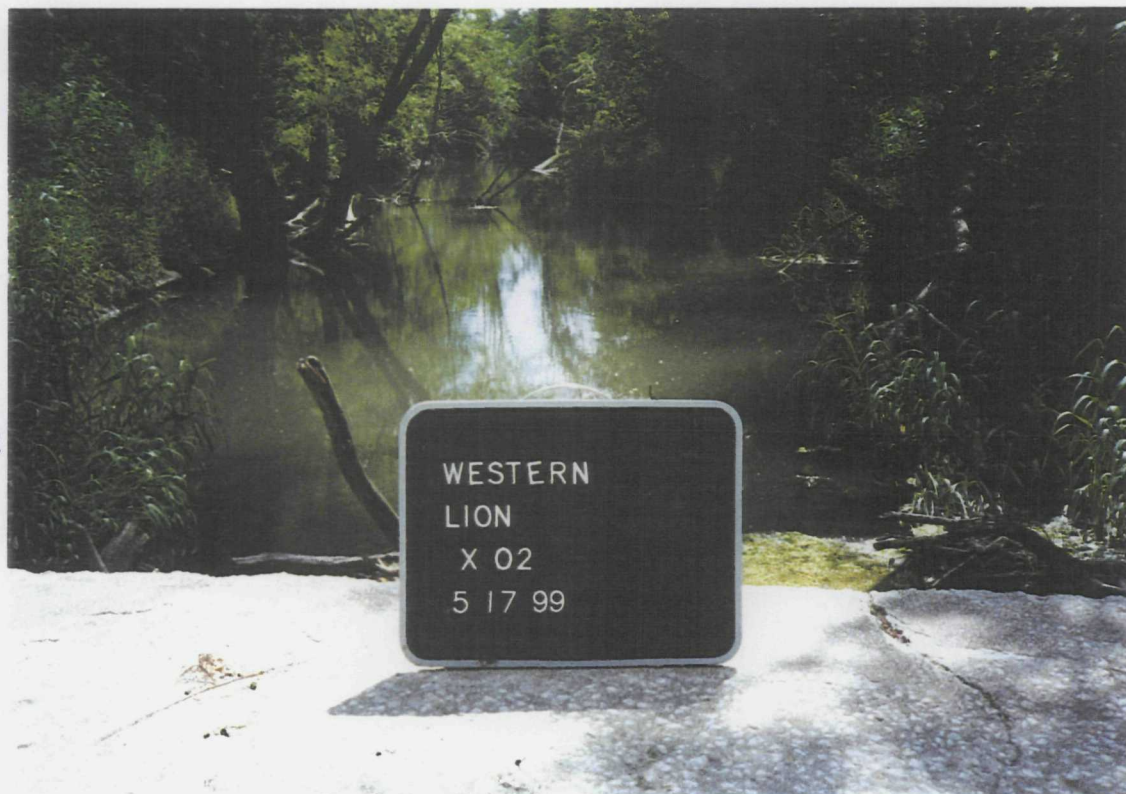
Sample Location: X202

X201	0 - 6"	Brown silt with gray clay.	Upstream of landfill.
X202	0 - 6"	Brown silt with gray clay.	Alongside the landfill.
X203/X204	0 - 6"	Black silt with gray clay and some sand.	Just downstream of the landfill.
X205	0 - 6"	Black silt with sand.	Farther downstream of the landfill.
